***Report No. UT-03.34***

***FLEXURAL PERFORMANCE OF  
RETROFITTED REINFORCED  
CONCRETE CANTILEVERED  
BENT CAPS – PART 2***

**Utah Department of Transportation  
Research Division**

**December 2003**

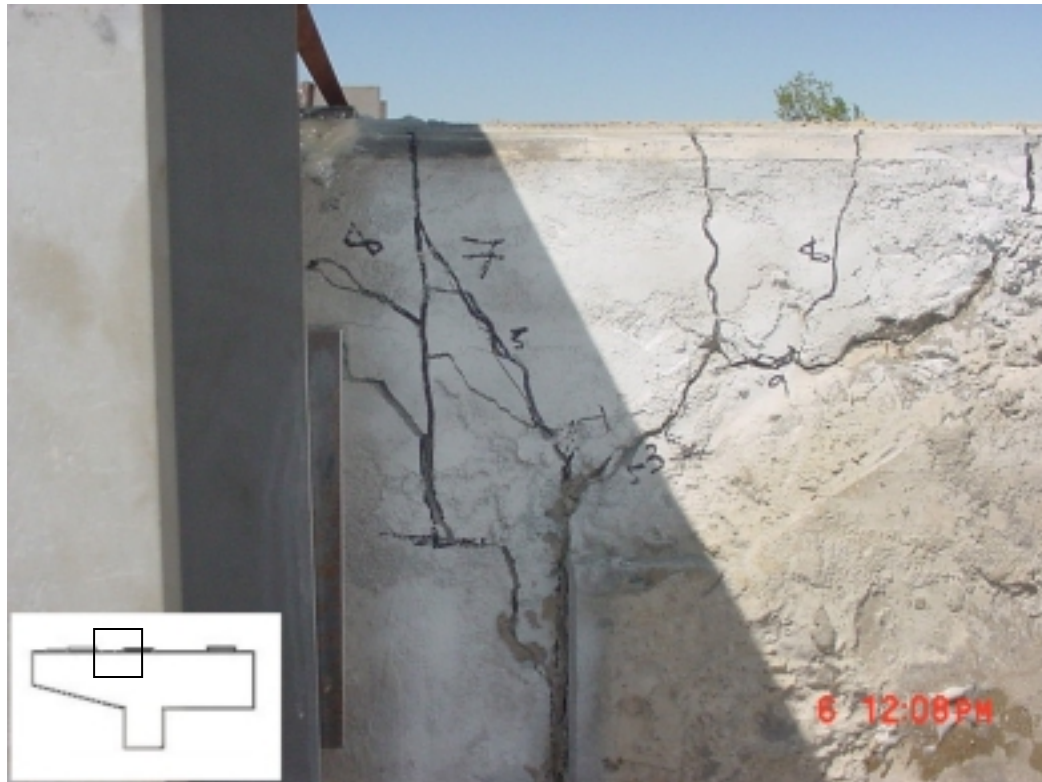
Figure 4.115 – Bent 13N, cracks on the face of the bent after cycle 8
